⑥ National Dam Inspection Program. **STORAGE DAM**
(NDI I.D. NO: PA-388 → Number
← Number DER I.D. NO: 24-47), Ohio River Basin,
Whetstone Branch of Little Toby
Creek, Elk County, Pennsylvania.
PHASE I INSPECTION REPORT,
NATIONAL DAM INSPECTION PROGRAM

NAME OF DAM: Storage Dam
STATE LOCATED: Pennsylvania
COUNTY LOCATED: Elk County
STREAM: Whetstone Branch of Little Toby Creek
SIZE CLASSIFICATION: Small
HAZARD CLASSIFICATION: High
DATE OF INSPECTION: April 6, 1979 and May 25, 1979

STORAGE DAM
(BROCKWAY)
NDI I.D. NO. PA-388
APRIL 6, 1979

PHASE I REPORT
NATIONAL DAM INSPECTION PROGRAM
STORAGE DAM
NDI I.D. NO. PA-388
DER I.D. NO. 24-47

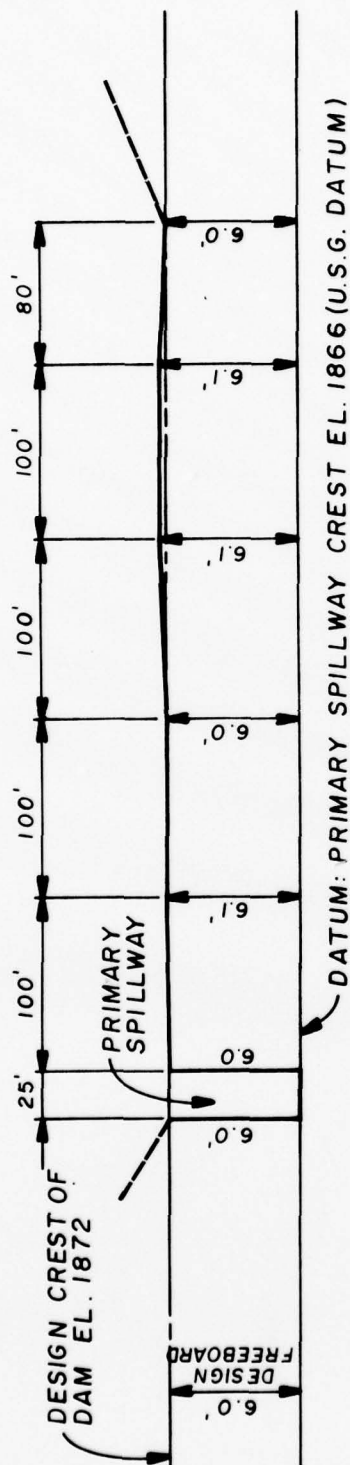
DAM CREST PROFILE (LOOKING UPSTREAM)

The top of the embankment was surveyed relative to the spillway crest elevation and was found to be in conformance with the design elevation. The crest profile is illustrated on Plate 12.
